NRL Memorandum Report 4003

Shock Performance of a Shipboard Electrical Switchgear

EDWARD W. CLEMENTS

June 15, 1979

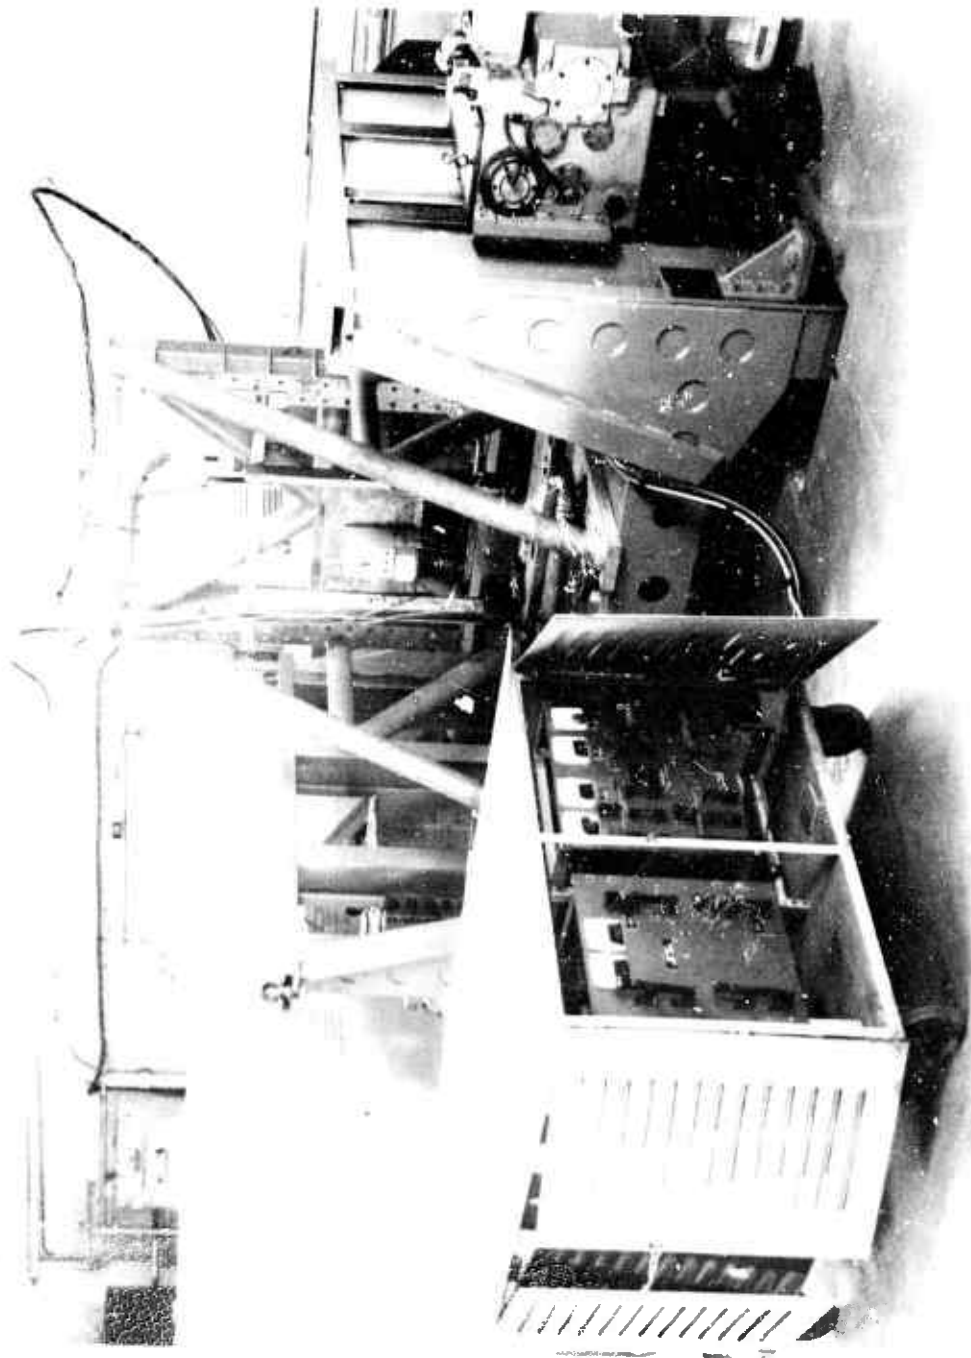
For vibration tests the LF101's were wired to a three-phase Y-connected resistive load and fed with 250v three-phase 60 Hz power. Current for No.'s 6, 10 and 14 was 90 amp, for No. 15, 50 amp. No mechanical or electrical activity could be detected for any of these breakers during or after the test. The test arrangement is shown in Figs. 1 and 2.

Fig. 1 - Vibration Test Setup. An AQB-LF101 circuit breaker is shown on the NRL 5000 lb Reaction-Drive Vibration Machine, arranged for vibration in the Horizontal-Parallel-to-Front plane. The Breaker is fed with 250 v 3 ϕ at 90 amp. The resistive load is in the foreground.

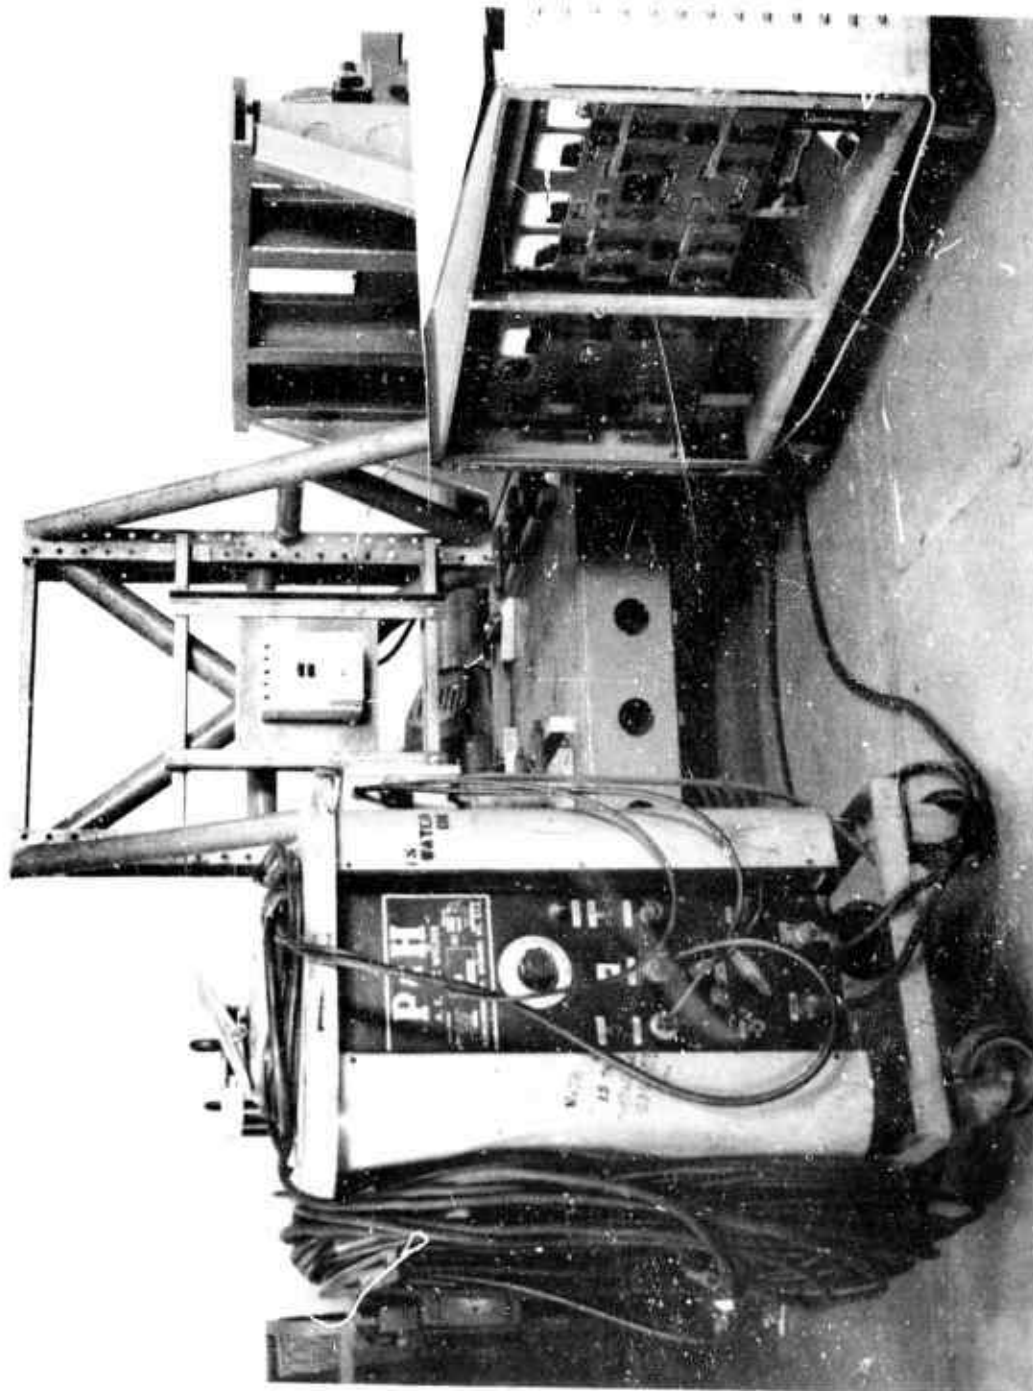
The LF250's were wired with poles series-fed to a single-phase resistive load, and energized with 40v single-phase 60 Hz at 250 amp from a welding machine. As with the LF101's, no effect of vibration could be detected. The test arrangement is shown in Figs. 3 and 4.

Fig. 3 - Vibration Test Setup for an AQ β -LF250 circuit breaker. The breaker is powered with 40 v l ω at 250 amp from the welding machine in left foreground.

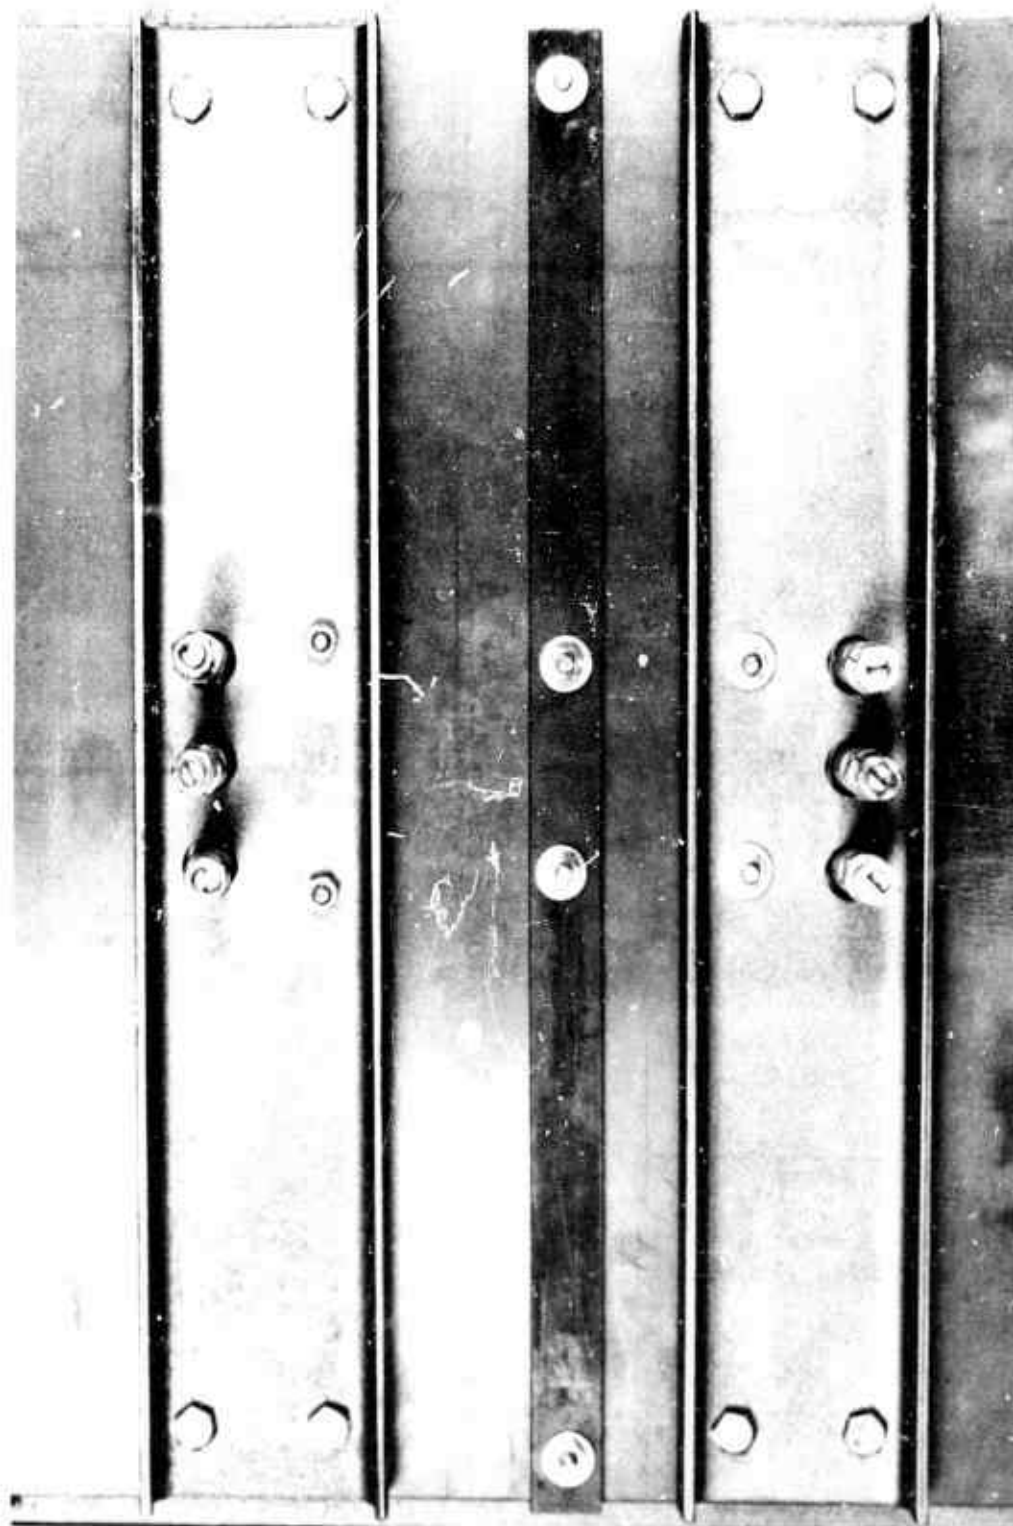
An additional stiffener bar (1 x 1/4 in. steel) (Fig. 9) was added to the back of fixture to see if a more rigid fixture would help. The breaker was then retested with the interlock actuator blocked and free, with the results of Table V.

Fig. 9 - Back view of the LF101 test fixture, showing the extra 1" x 1/4" stiffening bar added at center.

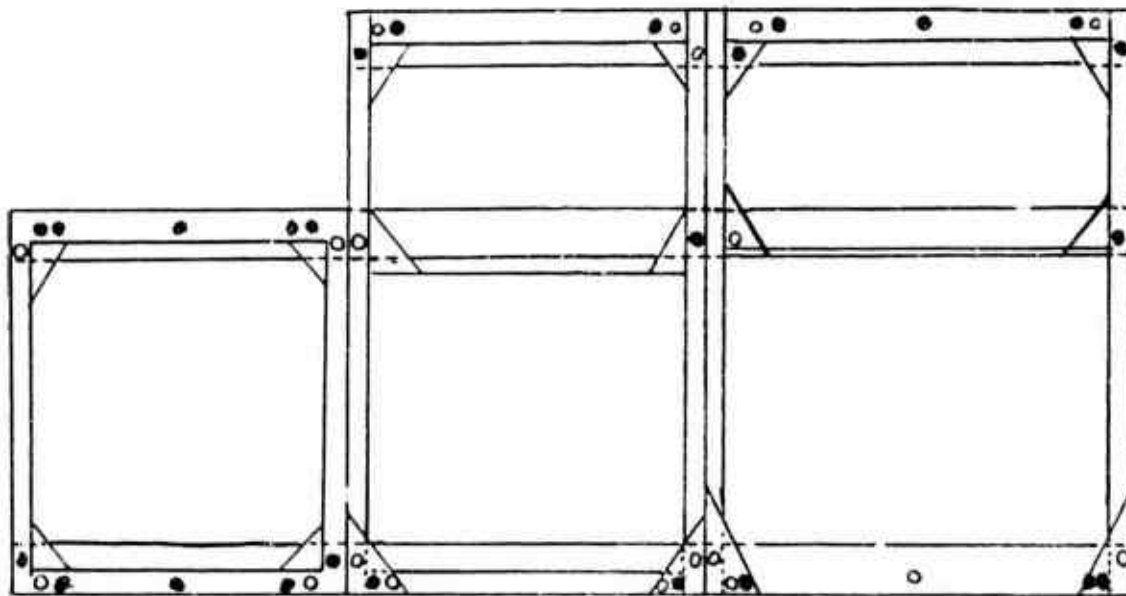
Fig. 24 - Sketch showing locations of switchgear hold-down bolts. Closed circles show bolts actually installed, open circles represent holes in the switchgear base which did not align with those in the channels.

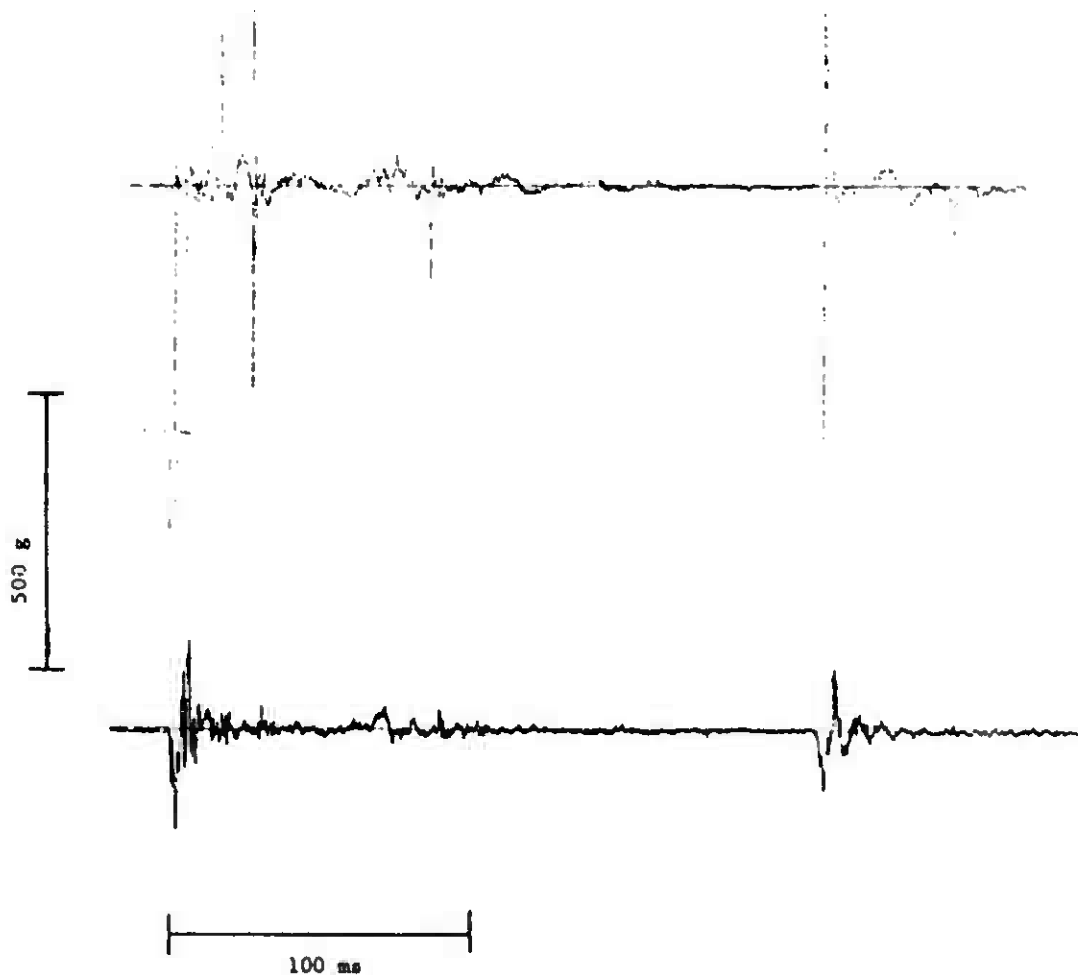
Fig. 65 - Acceleration-time records from the fuse block (upper) and mounting panel (lower) of AQB-LF101 No. 10A during Blow 4 (5-1/2 ft. 3 in.) (Vertical). Note spikes which probably indicate collision of the breaker and the cover panel.

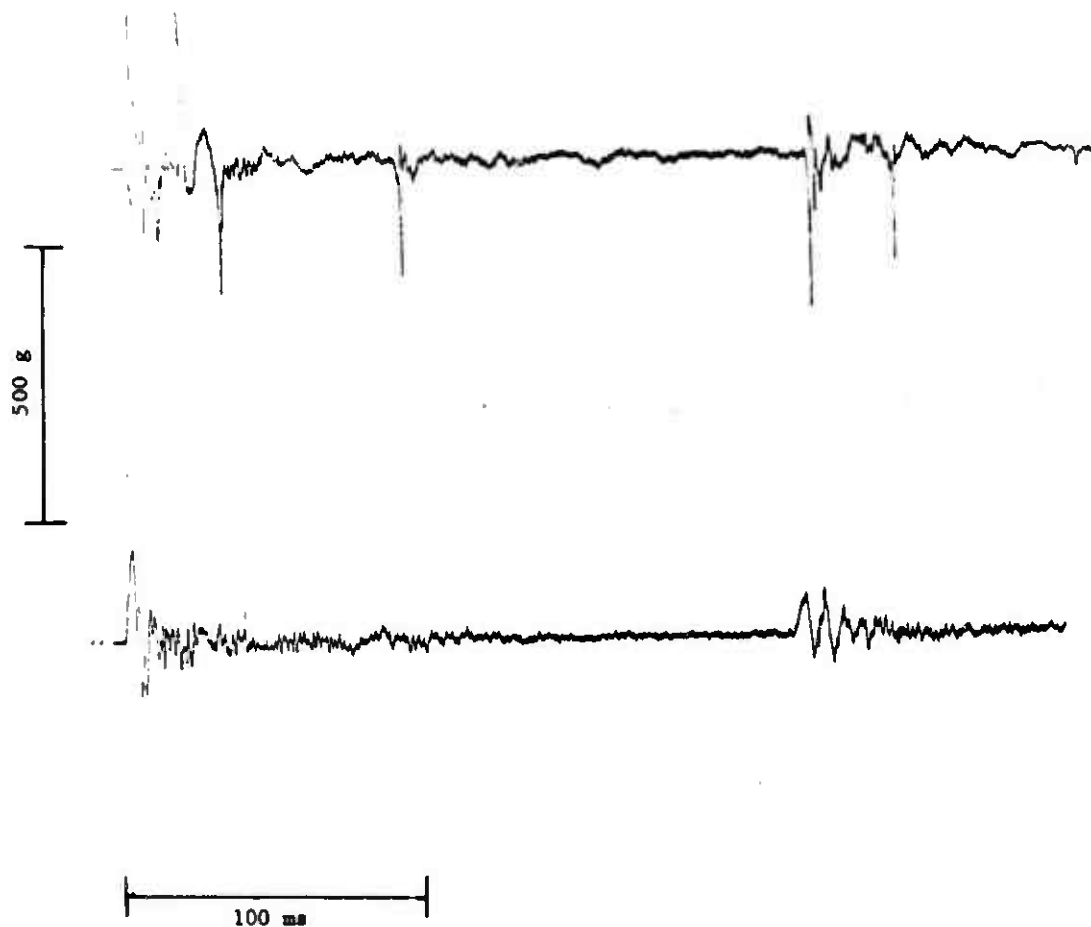
Fig. 67 - Acceleration-time records for the fuse block (upper) and mounting panel (lower) of AQB-LF101 No. 10A during Blow 9 (5-12/ft. 3 in.) (30° - Inclined). Note possible collision spikes.
